Bigger Than Expected

What appeared to be a routine video inspection turned into a major cleaning project for a pipeline services firm in Virginia

Inspect and clean 3,000 feet of 18-inch sanitary sewer line

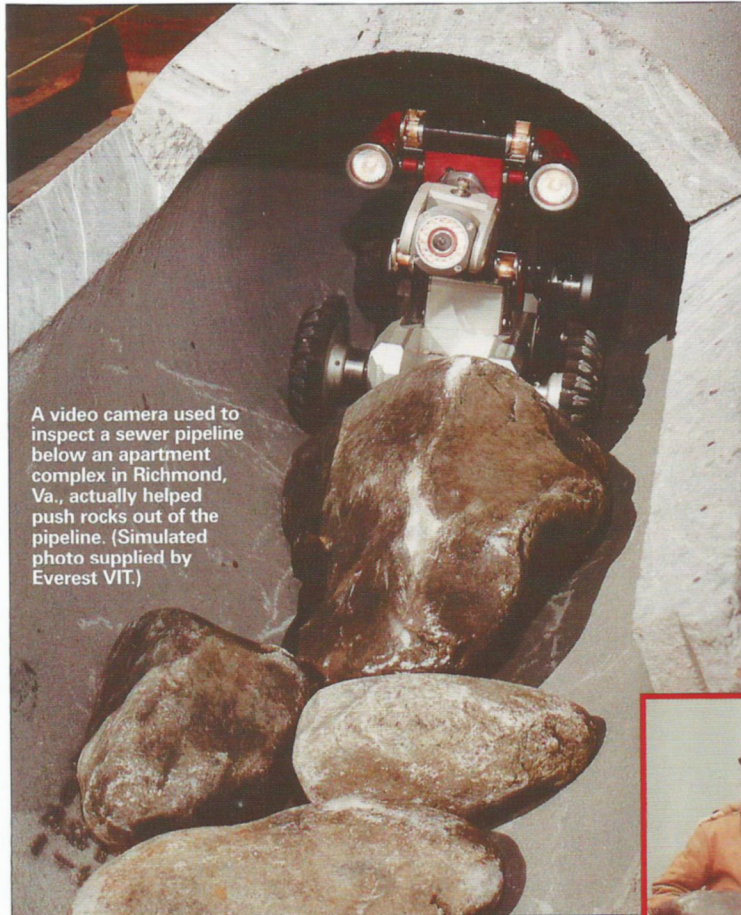
A video camera used to inspect a sewer pipeline below an apartment complex in Richmond, Va., actually helped push rocks out of the pipeline. (Simulated photo supplied by Everest VIT.)

On the last day of the inspection, conducted with water running through the line, the camera and crawler encountered an obstruction 380 feet into a pipe. It turned out to be a large rock.

The only way the crew could envision removing the rock was to push it with the crawler. "We did think that the force of the water would eventually lead it downstream," reports Norman. "We had used the crawlers in the past to move bricks and balls of grease, so we thought that, if we had to, we could push it to the next manhole."

The inspection crawler was soon pushing not just the first rock but also three smaller rocks picked up along the way. When the Capital City team met the crawler at the next manhole, they used a clamshell to remove the smaller rocks,

then entered the manhole to remove the largest rock by hand when the clamshell failed. It weighed 65 pounds. In all, the crawler had pushed 95 pounds of rock more than 100 feet.
